Residential Property Inspection Report

225 Edinburgh Ave
Monterey, CA 93940
Inspection Date: 05/15/2018

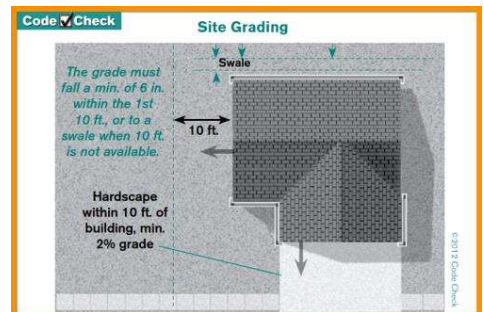
Site Grading

[CR] Areas of the surface grading lacked adequate slope to divert surface moisture away from the foundation of the building. This condition is conducive to moisture intrusion and/or deterioration of the building components. The grading should have a positive slope away from the building, dropping at least 6 inches in 10 feet or slope to a drainage system if the building is closer than 10 feet to the property line

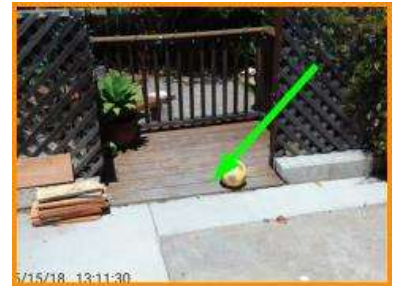
[SC] One or more of the stair treads (steps) were loose at the rear. The sudden realization of insecure footing on a set of steps/stairs is a trip/fall hazard.

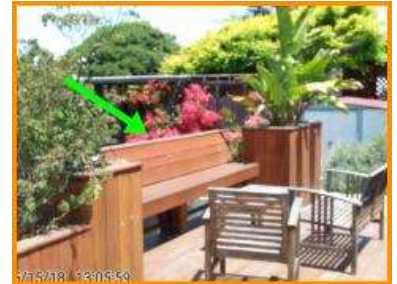
[SC] The guardrail(s) for the bench/seat at the right were too low to provide adequate protection against falling over the guardrail. The guardrails may have met the height standard at the time of construction but provide inadequate height protection by today's building standard. Current building practices call for residential guardrails to be a minimum of 42" inches above the seat.

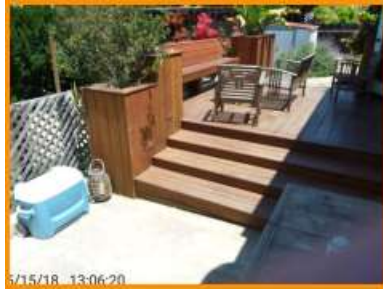
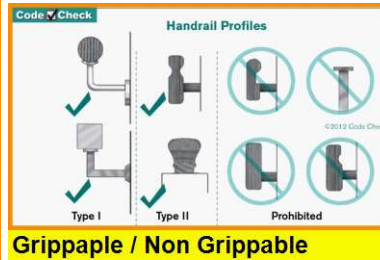
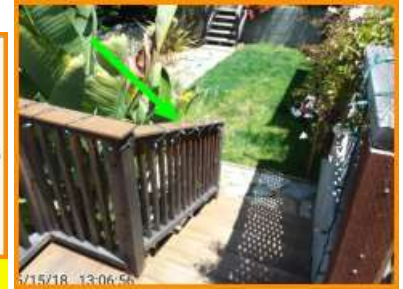
[SC] There were no handrail(s) for the steps/stairs at the rear. Full length handrails with newel posts or wall returns serve two purposes; the first is to indicate to the visually impaired that they have reached the end (top or bottom) of the steps/stairs. The second is to prevent clothing, garments or bags from getting hung up on the open-ended handrails and causing an accident.

[SC] The handrail(s) for the steps/stairs at the rear may have met the standards at the time of construction, however they are not considered to be hand grippable by today's standards. Appropriately sized and grippable handrails may be helpful in preventing a serious fall up or down the steps/stairs.

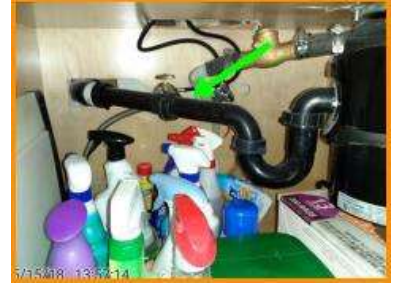
[CR] The drain pipe(s) had improper/reversed slope at the kitchen sink(s). This condition may lead to slow and/or blocked drains over time.

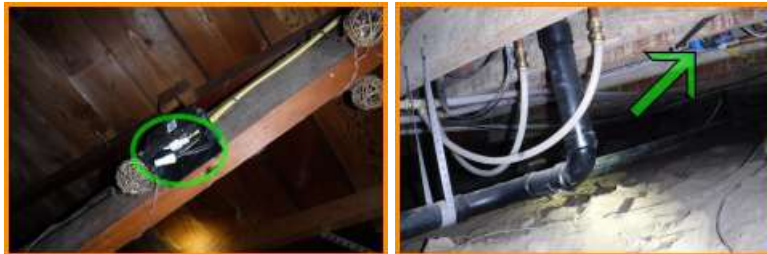
[SC] Junction-box cover plates were missing in/at the garage and crawlspace. This condition is a shock / electrocution hazard due to exposed electrical components; all electrical junction boxes should have an approved spark-proof cover. This is a potential fire hazard.

[SC] There was improper wiring in the form of ends of conductors not covered and exposed to contact with people and/or equipment in/at the garage. Improper wiring is conducive to electrical deficiencies and is a potential shock and fire hazard.

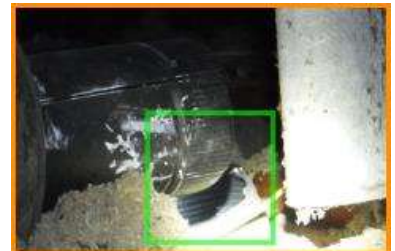
[SC] The mechanical range vent exhaust ducting for the fan in the kitchen was disconnected in the attic. This allows the moist greasy air to be exhausted into concealed spaces rather than safely outside - is conducive to moisture accumulation, damage to the building materials and is considered a potential fire hazard.

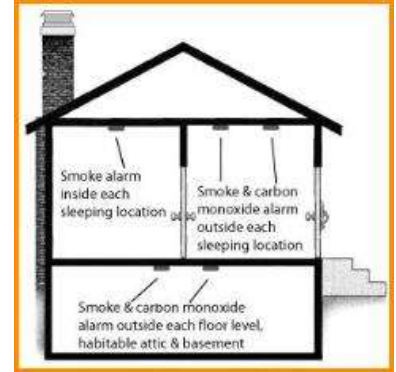
[SC] This structure contained smoke detectors which appeared to be beyond their service life. Smoke detectors have a service life of seven (7) to ten (10) years, after which they may no longer operate (even if their "test" function indicates they do). **All smoke detectors should be replaced with ones that contain 10 year batteries (whether battery only or wired with battery backup, as appropriate).** We recommend that all smoke detectors be of photoelectric style (which are known to work up to 40 minutes faster) rather than the older ionization style (which are known to fail 49% of the time).

We recommend installation of the photoelectric style vs. ionization detectors. Photoelectric are known to work 20 to 40 minutes faster than ionization and ionization are known to fail 50% of the time.
