WOOD DESTROYING PESTS AND ORGANISMS INSPECTION REPORT #: 20182195

BUILDING NO. 225	STREET EDINBURGH AVE	CITY MONTEREY	ZIP 93940	Date of Inspection 10/02/2018	NUMBER OF PAGES 1 of 5
---------------------	-------------------------	------------------	--------------	----------------------------------	---------------------------

WHEELER TERMITE CO.
9934 MIMOSA PATH
Salinas, CA 93907
PH# (831) 633-2284 Email b.wheeler1959@gmail.com
PR 3130

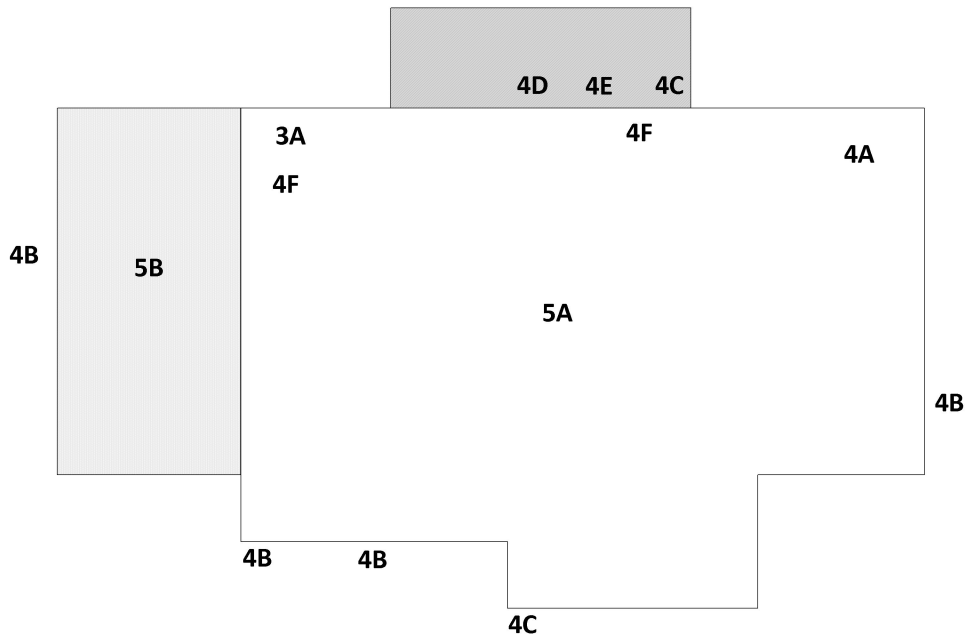
FINDING AND RECOMMENDATION: 3A FINDING (SEC. 1) FUNGUS INFECTION NOTED FLOOR JOIST AND TRIM AT SUB DOOR FRAME .

FINDING AND RECOMMENDATION: 4A FINDING: (SECTION 1) MOISTURE DAMAGE AS INDICATED BY 4A ON DIAGRAM. THE MOISTURE DAMAGE WAS TO WINDOW SILL.
 RECOMMENDATION: REMOVE DAMAGED MATERIAL AND REPLACE WITH TODAY'S AVAILABLE MATERIALS.

FINDING AND RECOMMENDATION: 4F
 FINDING: (INFORMATION ONLY)
 DRY WATER STAINS NOTED AS 4F ON THE DIAGRAM. THE STAINS WERE IN THE SUBAREA . NO MOISTURE WAS NOTED.
 RECOMMENDATION:
 NONE. NOTED FOR INFORMATION ONLY. PERIODICALLY INSPECT AREA.
 CONTACT THE APPROPRIATE LICENSED TRADES FOR MORE INFORMATION

RECOMMENDATION: 3A RECOMMENDATION: TREAT AREA WITH A REGISTERED FUNGICIDE (TIMBOR).
