WOOD DESTROYING PESTS AND ORGANISMS INSPECTION REPORT #: 20182195

BUILDING NO. 225	STREET EDINBURGH AVE	CITY MONTEREY	ZIP 93940	Date of Inspection 10/02/2018	NUMBER OF PAGES 1 of 5
---------------------	-------------------------	------------------	--------------	----------------------------------	---------------------------

WHEELER TERMITE CO.
9934 MIMOSA PATH
Salinas, CA 93907
PH# (831) 633-2284 Email b.wheeler1959@gmail.com
PR 3130

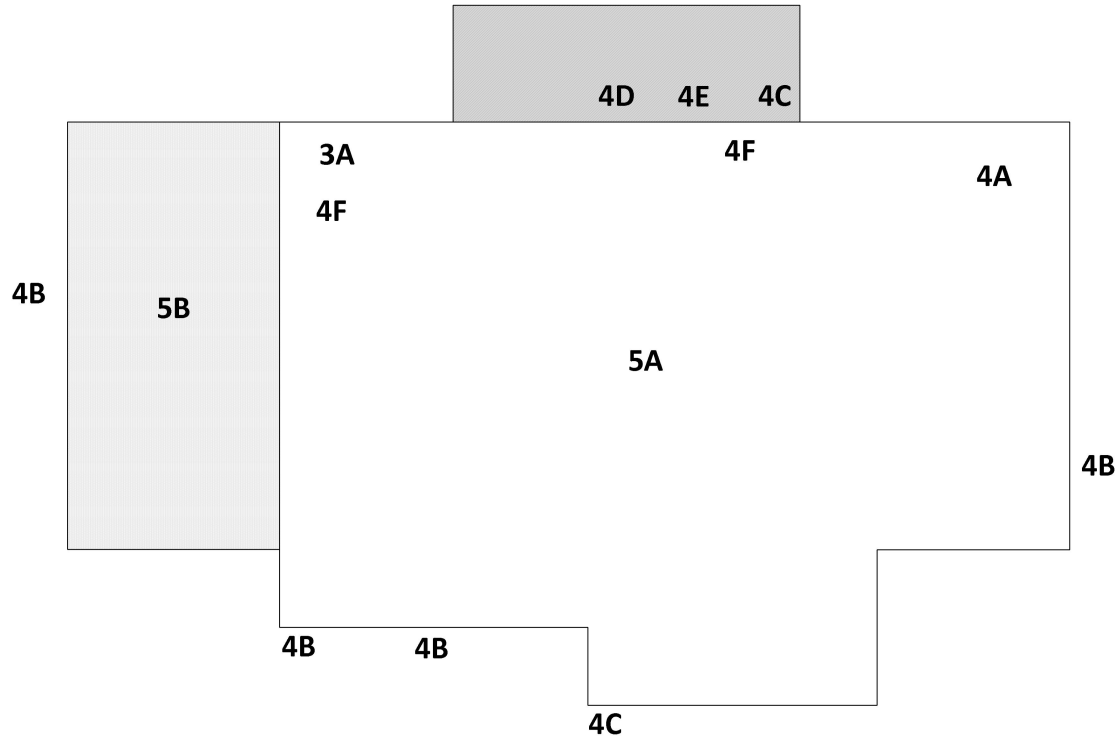
NOTE: If diagram is not displayed here, please see the report.

FINDING AND RECOMMENDATION: 4B FINDING (SECTION 2) THE STUCCO EXTERIOR WAS NOTED TO BE CRACKED IN AREAS.
 RECOMMENDATION: REPAIR/SEAL STUCCO AS NECESSARY TO PREVENT WATER INTRUSION

FINDING AND RECOMMENDATION: 4F
 FINDING: (INFORMATION ONLY)
 DRY WATER STAINS NOTED AS 4F ON THE DIAGRAM. THE STAINS WERE IN THE SUBAREA . NO MOISTURE WAS NOTED.
 RECOMMENDATION:
 NONE. NOTED FOR INFORMATION ONLY. PERIODICALLY INSPECT AREA.
 CONTACT THE APPROPRIATE LICENSED TRADES FOR MORE INFORMATION

FINDING AND RECOMMENDATION: 5B
 FINDING (SECTION NOT DETERMINED)
 THE GARAGE IS PARTIALLY INACCESSIBLE DUE TO STORAGE.
